IMPROVEMENT OF THE LONG PULSE OPERATION OF THE FEL LINAC AT NIHON UNIVERSITY

Abstract

Some improvements to the high power RF system of the 125 MeV linac have been performed to realize a stable long pulse operation of the linac. The breakdown of the klystron RF window occurred in 8 klystrons at early phase of the linac operation. However, the problem has been avoided by the improvement to the vacuum conductance around the RF windows and by a careful conditioning. The Mitsubishi PV3030 type klystrons, which were moved from KEK, have been operated successfully at the peak output RF power of 20 MW, the RF pulse width of 20 μ s and the repetition rate of 12.5 Hz.

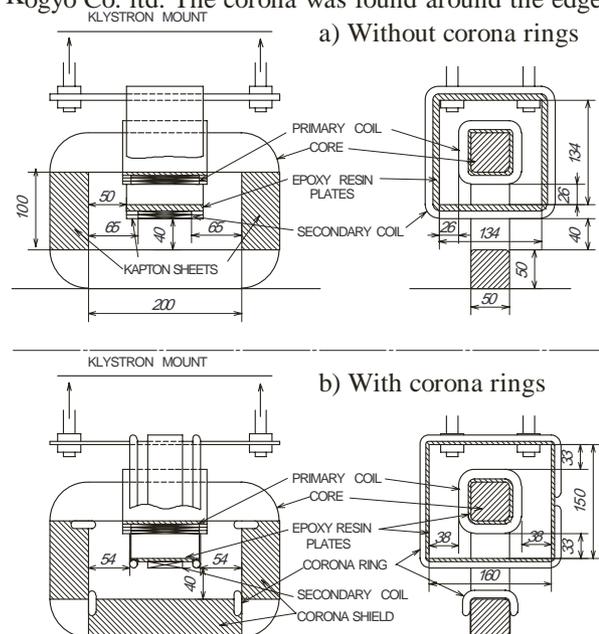
The structure of the heater isolation transformer is shown in a) of Figure 1. The transformer, together with the pulse transformer, was fabricated by Nihon Denji Kogyo Co. Ltd. The corona was found around the edge of

Figure 1. Layout of the heater isolation transformer.

the secondary winding inside the cut core in every pulse. The breakdown was found to occur between the edge and the polyimide (kapton) sheet wrapping the cut core, which was observed with a TV camera through a viewing window in the assembly tank.

Generally, high quality insulating oil has a dielectric strength greater than 30kV/mm. Minimum separation of 26mm between the primary and the secondary coils was enough if the electric field distribution was the same as those between plane electrodes. However, it was evident that the electric field on the thin edge of polyimide sheets wrapping the secondary winding or on the edge of the epoxy resin plates was greater than the dielectric strength.

When the transformer was disassembled, a significant carbonization was found extensively on the surface and the inner layer of the epoxy resin plates.

At the renewal of the heater transformer, the following improvements have been made to the structure of the transformer, as shown in b) of Figure 1:

- 1) The inner size of the secondary coil frame has been extended from 134×134mm to 160×150mm, while the thickness of the epoxy plates has been reduced from 8mm to 4mm. Then minimum separation between primary and secondary coils has been extended to 33mm.

- 2) The ordinary epoxy resin plates used as the coil frame have been replaced with the void-less ones. Also the polyimide sheets that were used to wrap the coils have been replaced with the kraft papers.

- 3) In order to avoid the strong field around the coil edges, copper corona rings have been added at both side edges of the epoxy resin plates of the secondary coil frame.

- 4) The whole edge of the cut core has been rounded off. In the previous cut core, only the inside edge was rounded off.
- 5) The polyimide sheets that were used to wrap the cut core have been removed. The rounded copper sheets have been substituted as the corona shields.

- 6) The corona ring has been added at each inside corner of the cut core.

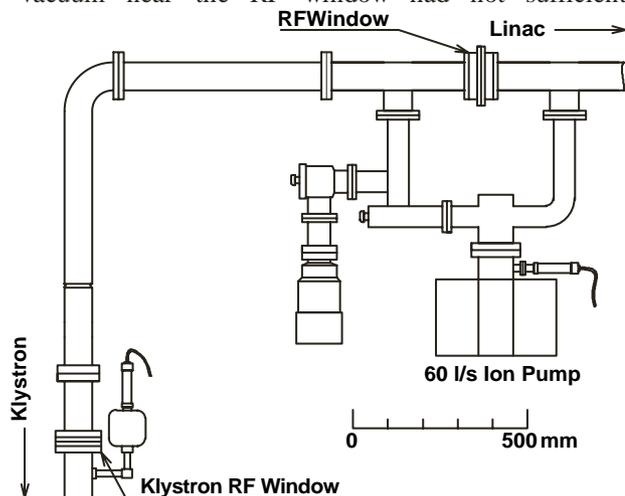
The vacuum in the waveguide was pumped with a 60 l/s ion pump located about 2.6 m downstream the RF window, which is illustrated in Figure 2. The vacuum conductance at the RF window was estimated to be approximately 8.2 l/s[2]. During the aging of the klystrons at LEBRA the long pulse output RF from the klystron, even at quite low power level, led to a considerable degradation of vacuum around the outer surface of the RF window.

At high power output operation, though the klystron was aged carefully, the dielectric breakdown that sometimes occurred at the RF window surface caused degradation of vacuum instantly by 1 to 2 orders of magnitude. Because of low vacuum conductance, the vacuum near the RF window had not sufficiently

Figure 2. Layout of the waveguide and the vacuum pumping system with a low vacuum conductance.

recovered before the next RF pulse, which caused the dielectric breakdown again. After these conditions were repeated many times in the operation of the linac, the window was finally broken.

The second RF window on the way to the linac accelerating tubes is shown in upper side of Figure 2, which is placed because of convenience in the maintenance of the linac. Although there was no essential difference from the klystron RF window on the material or the RF power suffered, the window was never damaged. The important difference seemed to be the distance from the ion pump, which means the difference of the vacuum conductance.

The vacuum conductance at the second RF window was estimated to be approximately 20 l/s, which is about 2.5 times greater than that at the klystron RF window. It suggests that a quick recovery from the degraded vacuum at the window surface is essential to avoid the damage of the klystron RF window.

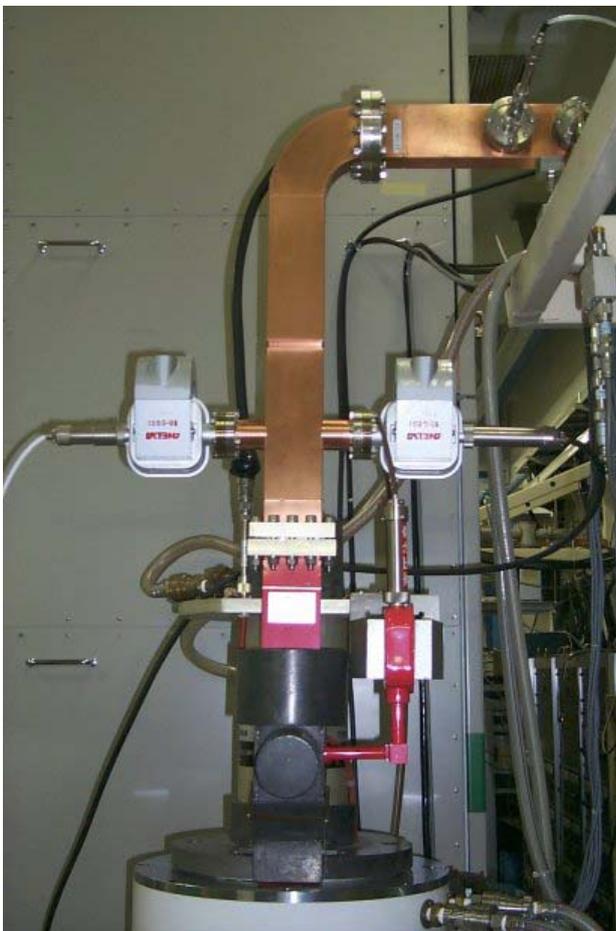
Figure 3. The photograph of the waveguide with two additional vacuum pumps downstream the klystron RF window

Considering these factors, additional two vacuum ports were put to the waveguide at about 40cm downstream the klystron RF window as shown in Figure 3. The vacuum conductance at the RF window associated with these ports is estimated to be 43 l/s. For easier installation ANELVA 8 l/s ion pump has been connected to each port.

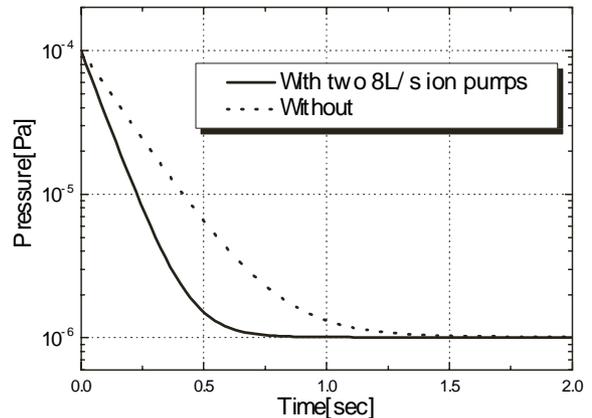
A vacuum recovery simulation suggests that a fast recovery of the vacuum is expected around the klystron RF window as shown in Figure 4, where the simulation has been performed with an assumption that the vacuum at the surface of the klystron RF window changes instantly from 1×10^{-6} Pa to 1×10^{-4} Pa by the dielectric breakdown.

Figure 4. The result of simulation for the vacuum recovery after the dielectric breakdown at the klystron RF window.

The dielectric breakdown in successive RF pulses has been considerably suppressed since the vacuum system was improved. The peak output RF power of 20MW from PV3030 klystrons has been achieved at the pulse width of 20 μ s and the repetition rate of 12.5Hz. The klystrons have been operated more than 1000 hr at 2 Hz without damage to the RF windows since the vacuum pumping was increased.
